Town of Arlington, Massachusetts

PART A – Executive Summary Self- Evaluation and Transition Plan

November 2019

Part A – Executive Summary

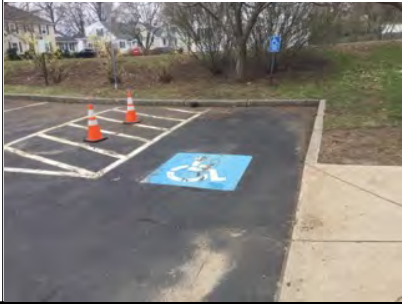
Running or cross slope at access aisle > 1:50 (2.00%) Sign does not have the designation "Van Accessible" Sign bottom < 60" above finished grade	4% - 44"	Reduce running or cross slope to be no steeper than 1:50 (2.00%). Add the designation "Van Accessible" to the sign located at the van accessible space. Locate sign with the bottom of the sign 60" above the ground.	1	1076	\$1076
Access to Goods and Services												
77	Picnic Tables Near Garden	Ext.		Picnic Tables	N/A

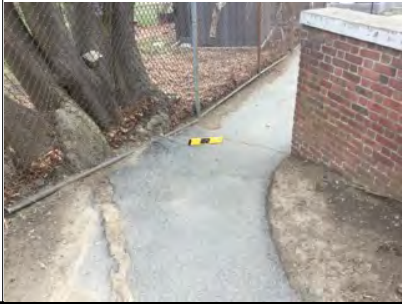
-	Best Practice: Off-property tree roots create an exceedingly high slope (40%) at this portion of the route. Consider removing tree roots, reconstructing path, or otherwise providing an accessible route.	1	-	\$0

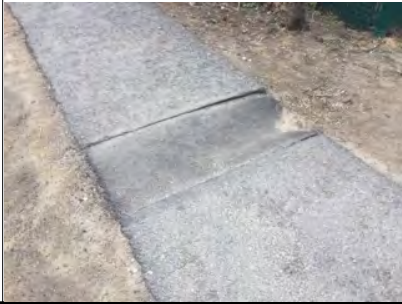
Route not maintained in operable working condition	-	Ensure the accessible route is maintained in operable working condition. (Cost estimate based on 3 linear ft. of asphalt.)	1	78	\$78
Access to Goods and Services												
81	Boys' Toilet Room Near Cafeteria	G	G01	Signage	Designation

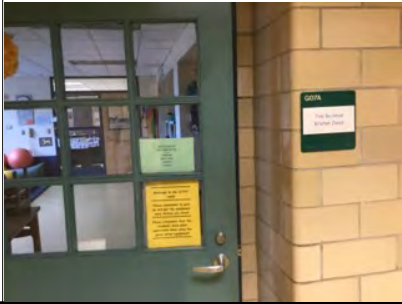
Braille misplaced	-	Do not block raised characters and/or braille with printed out signs. Replace signage if current designation does not correspond with old sign.	1	116	\$116
Additional Access												
89	OT/PT Room	G	G07a	Sink	Classroom

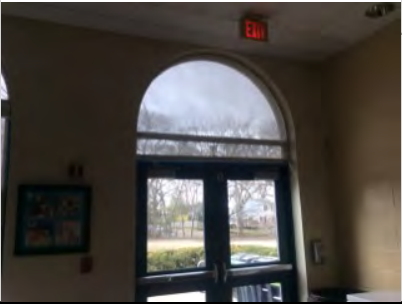
International Symbol of Acc. not provided Tactile exit sign not provided	- -	Provide an illuminated sign with the International Symbol of Accessibility. Provide a tactile exit sign with raised characters and braille are provided at exit doors. Mount signs between 48" - 60" above the finished floor on the latch side of the door.	1	232	\$232
Best Practice												
10	Cafeteria	1	103		Stairs

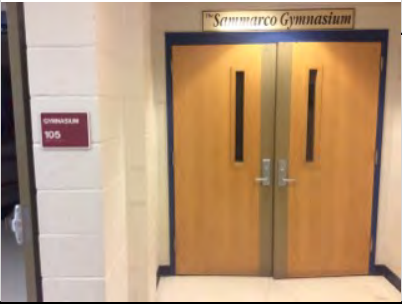
Sign not located on the latch side of the door	-	Locate sign at permanent rooms alongside the door on the latch side. Where a tactile sign is provided at double doors with two active leafs, the sign shall be located to the right of the right hand door.	1	Labor	\$0
Access to Goods and Services												
14	General Office	1	106	Signage	Designation

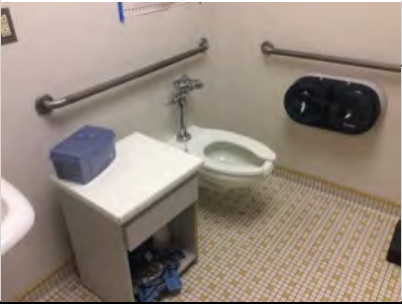
Clearance at toilet < 60" clear width Toilet paper dispenser is not compliant	- -	Remove cabinet to provide a clear width at that toilet that is 60" wide min. Replace toilet paper dispenser with one that allows continuous paper flow.	1	353	\$353

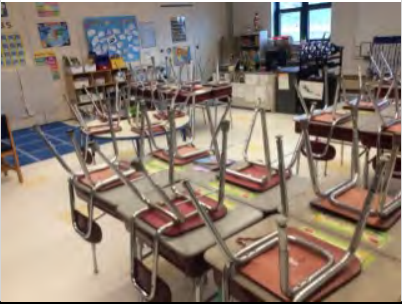
At least one or 5% accessible tables not provided	-	Provide at least one (1) accessible table with 24" min. knee clearance and 30" min. clear width. Ensure accessible work surfaces are well integrated with class seating plans.	1	350	\$350
Additional Access												
22	5th Grade Classroom	1	111	Sinks for Children's Use	543

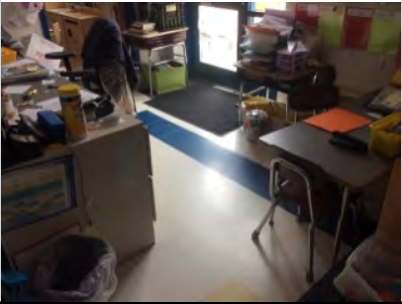
Route < 36" wide	33"	Reconfigure room to ensure that a clear width of 36" min. is maintained at the accessible route to the exit door	1	Labor	\$0
Approach and Entrance												
36	Kindergarten 121	1	121	Emergency Exit	N/A

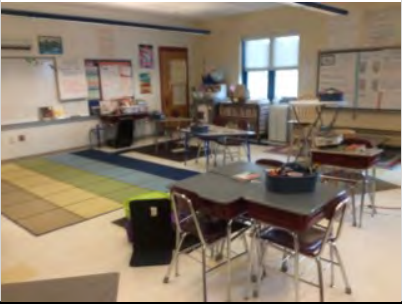
At least one or 5% accessible tables not provided	-	Provide at least one (1) accessible table with 24" min. knee clearance and 30" min. clear width. Ensure accessible work surfaces are well integrated with class seating plans.	1	350	\$350
Additional Access												
54	4th Grade Classroom	2	205	Sinks for Children's Use	Classroom

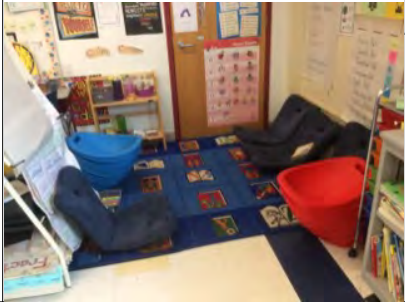
Maneuvering clearance(s) not provided	- -	Relocate reading area beyond the door maneuvering clearance. The door should have 60" clear in front of it with 18" clear on the latch pull side of the door.	1	Labor	\$0
Access to Goods and Services												
58	Classroom 220	2	220	Dining or Work Surfaces	Work Surface

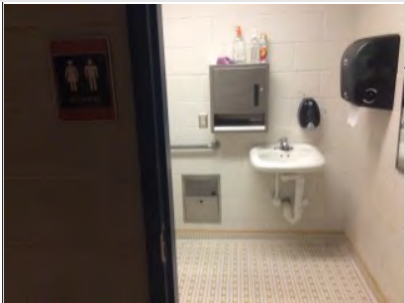
Raised characters not provided Braille not provided International Symbol of Acc. not compliant	- - -	After toilet room is made accessible, replace paper sign with a sign containing the International Symbol of Accessibility, as well as raised characters duplicated in braille.	1	116	\$116

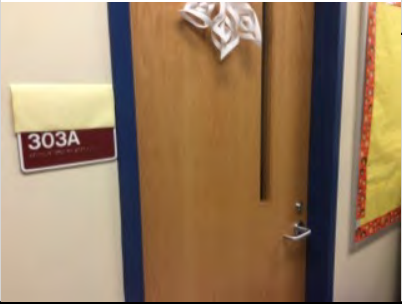
Sign not located on the latch side of the door	-	Locate sign at permanent rooms alongside the door on the latch side.	1	Labor	\$0
Access to Goods and Services												
72	Counseling Office	3	303B	Operable Parts	Other

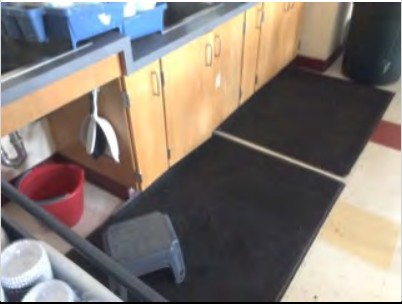
Surface not stable, firm, and slip-resistant	-	Secure the mats.	2	Labor	\$0
Additional Access												
76	Classroom 306	3	306	Sinks for Children's Use	Classroom

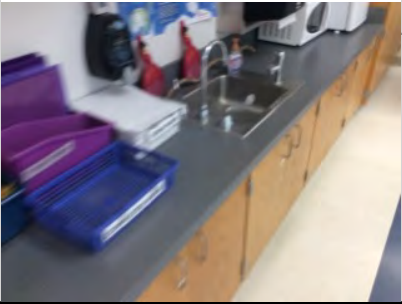
Knee or toe clearance not provided	-	Provide at least one sink with 25" knee and toe clearance positioned for a forward approach.	1	843	\$843
Access to Goods and Services												
85	5th Grade Classroom (Alternative)	3	322	Dining or Work Surfaces	Work Surface

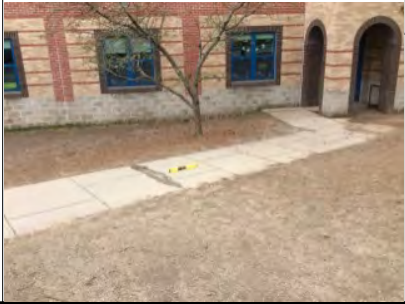
Running slope > 1:20 (5%)	5.5%	Regrade path so running slope does not exceed 5% running slope. Alternatively, provide handrails. (Cost estimate based on regrading 30 ft. of concrete pathway.)	1	1380	\$1380
Best Practice												
94	Stairs	Ext.			Stairs

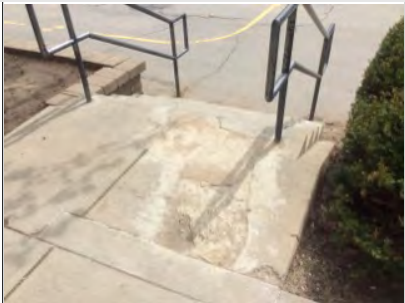
Best Practice: IHCD strongly recommends repairing stairs where the concrete is spalling.	1	-	\$0
Play and Sport Areas												
95	Streetside Playground	Ext.		Play Areas	N/A

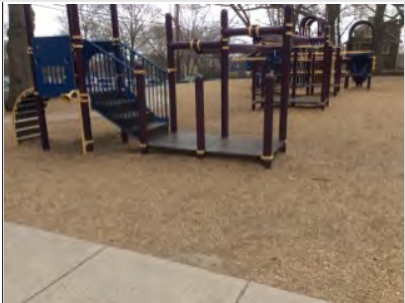
Accessible route not provided to ground level play components Not connected to an accessible route Surface not stable, firm, and slip-resistant	- - -	Provide a 60" wide min. impact-attenuating rubberized surface path to all play components. (Cost estimate based on installation of 195 total linear ft. of rubberized surface connecting all play component entrances to the accessible route.)	1	13650	\$13650

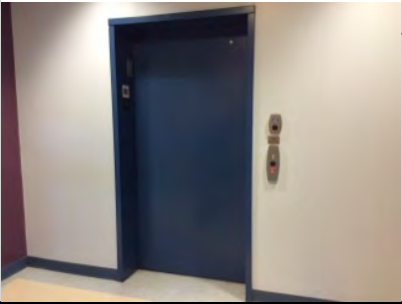
Hoistway signs not on both jambs	-	Provide hoistway signs on both sides of jambs. At the main entry level, ensure the hoistway signs have a tactile star.	4	48	\$192
Access to Goods and Services												
2	Administration Office	1		Operable Parts	Equipment

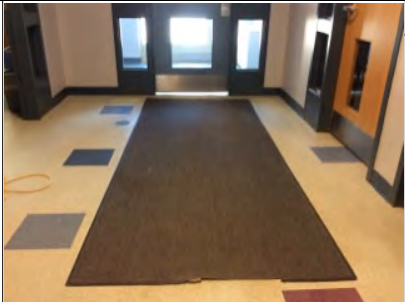
Mat not securely attached	-	Securely attach mat.	1	Labor	\$0
Access to Goods and Services												
6	Exit 2	1		Means of Egress	N/A

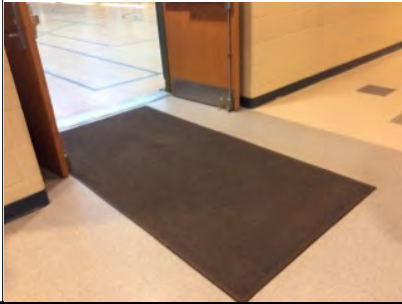
Mat not securely attached	-	Securely attach mat.	1	Labor	\$0
Access to Goods and Services												
10	Main Entrance	1		Means of Egress	N/A

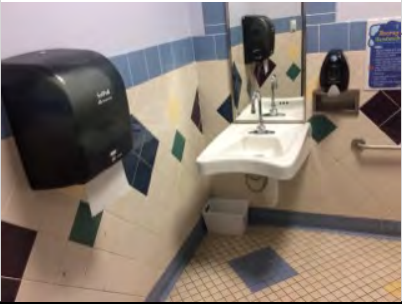
Dispenser acts as a protruding object	-	Relocate paper towel dispenser out of the circulation path.	1	353	\$353
Access to Goods and Services												
19	Music Room	1	112	Interior Access Route	N/A

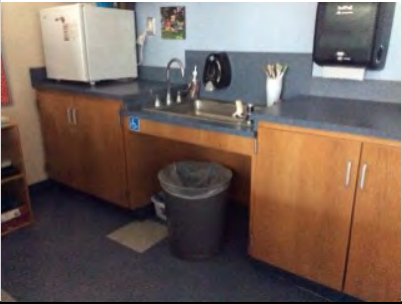
Clear floor space not provided at sink	-	Provide a 30" by 48" clear floor space positioned for a forward approach. Ensure the area beneath the sink is clear of obstructions.	18	-	\$0
Access to Goods and Services												
23	Cafetorium, Accessible Route to Stage	1	117	Ramps	Interior

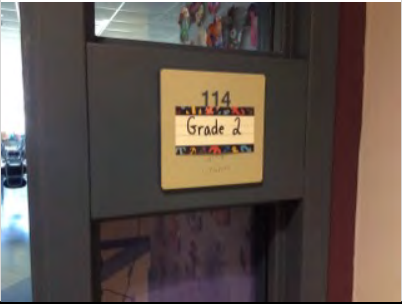
Braille misplaced	-	There are multiple instances where paper signs are placed over the raised characters and braille provided. Ensure these paper signs are relocated to remain compliant.	6	Labor	\$0
Access to Goods and Services												
39	Classrooms Throughout School	1 2	114,132, 133,142, 147,157, 207,212, 214,221, 223,224, 225,226, 227,228, 229	Dining or Work Surfaces	Work Surface

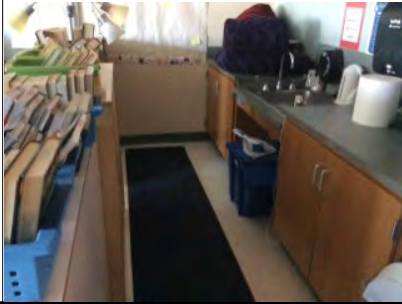
Route < 36" wide	33"	Ensure that a clear width of 36" min. is maintained at the accessible route and 48" at the sink. Relocate furniture.	1	Labor	\$0
Access to Goods and Services												
48	Classroom	2	213	Interior Access Route	N/A

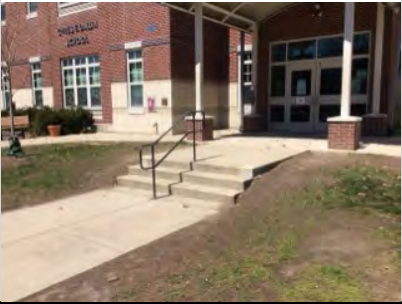
Best Practice: Recommend providing an additional handrail to each side of the staircase at the main entrance (as long as 36" is kept clear).	1	-	\$0
Approach and Entrance												
52	Main Entrance Loading Zone	Ext.		Curb Ramp	N/A

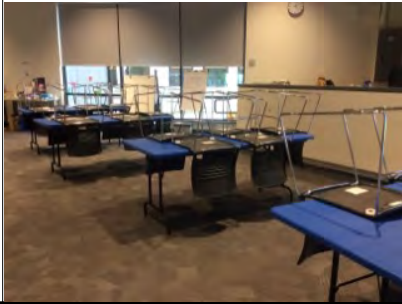
Not on a accessible route	-	Ensure dining or work surfaces are located on an accessible route. There is no interior accessible route to this part of the theater. Relocate seating for public programs in the lower accessible portion of the theater.	6	Labor	\$0
Toilet & Bathing Rooms												
18	Boys' Toilet Room Near Cafeteria	1	119	Toilet Compartment	Accessible Compartment

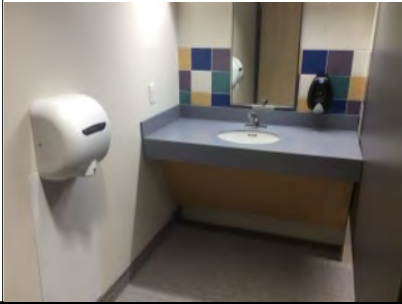
Dispenser acts as a protruding object	36"	Relocate the hand dryer out of the circulation path.	1	353	\$353
Additional Access												
20	Classroom	1	121 123	Sink	Classroom

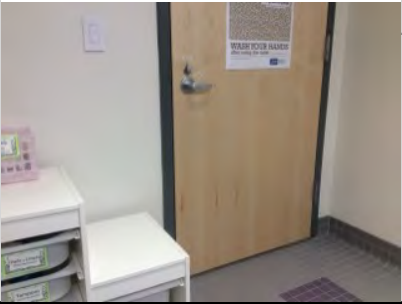
Maneuvering clearance(s) not provided	-	Relocate the shelving unit to provide 18" clear on the latch pull side of the door.	1	Labor	\$0
Toilet & Bathing Rooms												
22	Toilet Room in Nurse's Office	1	126	Dispensers	Paper Towel Dispenser

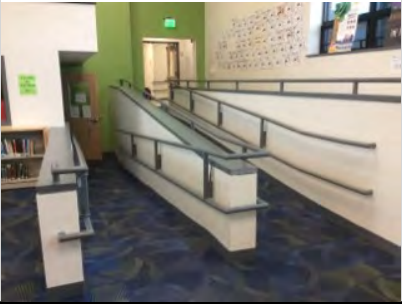
Ramp < 48" wide Running slope >1:12 (8.33%)	43" 9.2%	Repair to this ramp might be technically infeasible.	1	-	\$0
Access to Goods and Services												
35	Vestibule to Boys' Toilet Room	2		Doors, Doorways, & Gates	Toilet Room

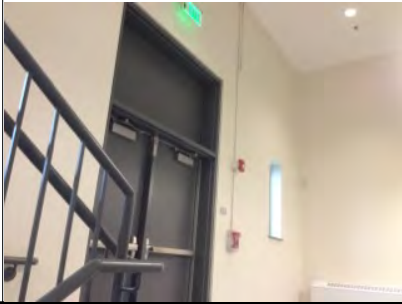
Tactile exit sign not provided	-	Ensure tactile exit signs with raised characters and braille are provided at exit doors. Mount signs between 48"- 60" above finished floor located on the latch side of the door.	1	116	\$116
Access to Goods and Services												
44	School Counselor's Office	2	207	Dining or Work Surfaces	Work Surface

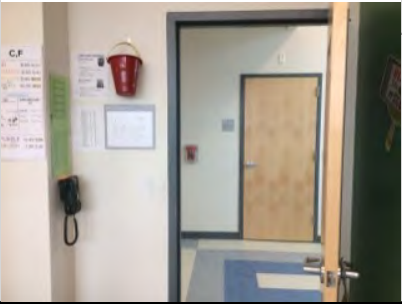
Reach < 15" or > 48"(forward/side approach)	66"	Relocate bucket to be between 15"- 48" above the finished floor. Locate it away from the door maneuvering clearance and out of the circulation path.	1	Labor	\$0
Access to Goods and Services												
48	Breakout Space	2	2A	Doors, Doorways, & Gates	N/A

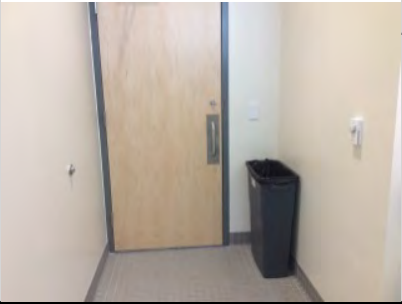
Maneuvering clearance(s) not provided	-	Relocate the trash can to provide 18" clear on the latch pull side of the door.	1	Labor	\$0
Access to Goods and Services												
52	Science Room	3	304 310	Dining or Work Surfaces	Work Surface

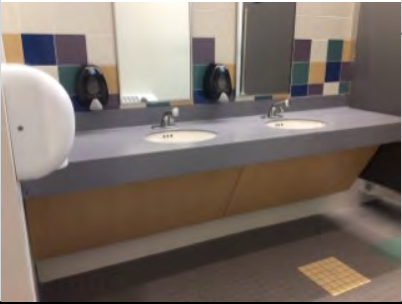
Dispenser acts as a protruding object	36.5"	Relocate the hand dryer out of the circulation path.	4	353	\$1412
Access to Goods and Services												
56	Classrooms Throughout School	3, 2, 1		Doors, Doorways, & Gates	Classroom

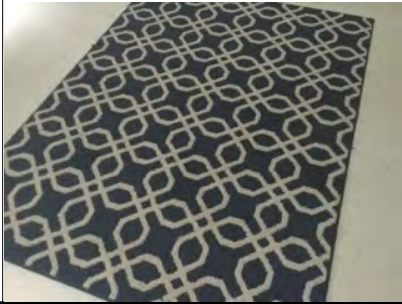
Surface not stable, firm, and slip-resistant	-	Securely attach all the mats in the room.	3	Labor	\$0
Access to Goods and Services												
6	Reading Room, Kindergarten Classroom	1	104A 121	Dining or Work Surfaces	Work Surface

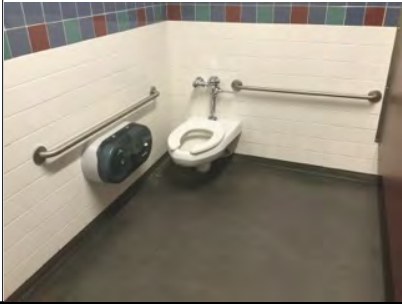
Non-compliant toilet paper dispenser	-	Replace toilet paper dispenser as it does not allow continuous paper flow.	1	353	\$353
Toilet Rooms for Children												
31	Girls' Toilet Room	1	120 / 107	Toilet Compartment	Accessible Compartment

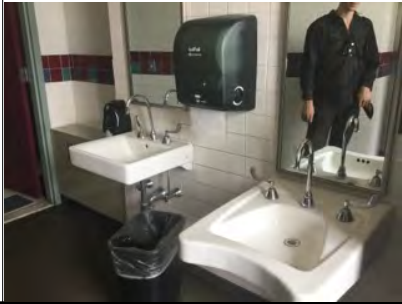
Dispenser not operable with a closed fist	-	Provide a paper towel dispenser that can be operable with one hand and not require tight grasping, pinching, or twisting of the wrist.	1	453	\$453

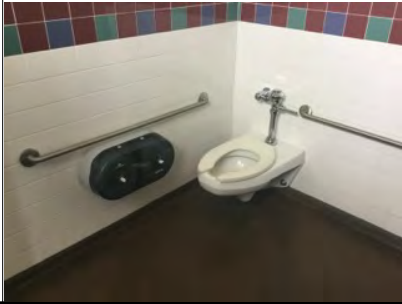
Clearance at toilet 72" clear depth Coat hook not within reach range	60" 51.25"	Provide a wheelchair accessible compartment that is 60" wide min. and 72" deep min. Best Practice: Lower hook so that it is no higher 40"	1	3091	\$3091
Access to Goods and Services												
66	Girls' and Boys' Toilet Rooms	2	211 / 219 210 / 218	Doors, Doorways, & Gates	Toilet Room

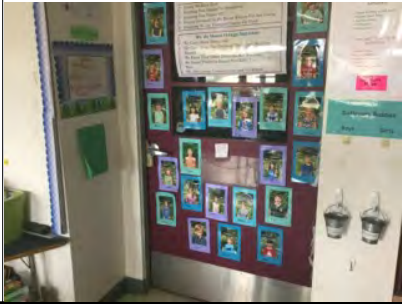
Maneuvering clearance(s) not provided	-	Note: On March 22, 2018; The Massachusetts Office of Public Safety and Inspections Architectural Access Board granted relief for this condition.	1	-	\$0
72	Fourth Grade Classroom	2	212B	Doors, Doorways, & Gates	Classroom

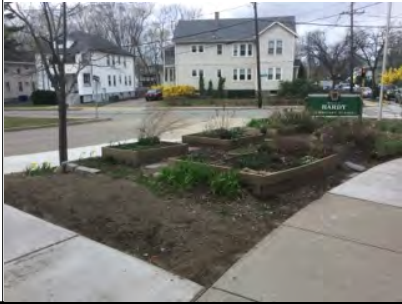
Accessible route not provided	-	Ensure an accessible route is provided to and around the community garden. (Cost estimate for 30' long 4' wide stone dust route around community garden.)	1	904	\$904
Approach and Entrance												
99	Exit 1, Main Entrance	Ext.		Entrance	Main Entrance

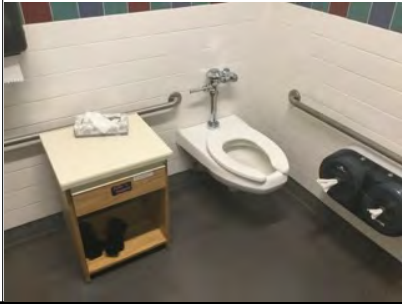
Non-compliant toilet paper dispenser Clearance at toilet < 60" clear width	- -	Replace toilet paper dispenser as it does not allow continuous paper flow. Relocate table out of the clear floor space required at the toilet.	1	706 Labor	\$706
Access to Goods and Services												
128	Main Entrance 1	G	G05A	Means of Egress	N/A

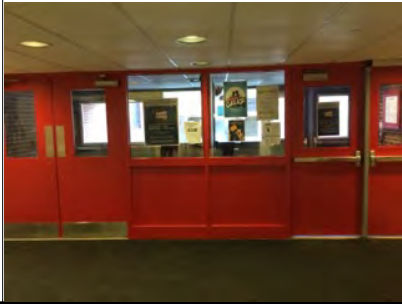
International Symbol of Acc. not provided Tactile exit sign not provided	- -	Provide the International Symbol of Accessibility. Provide a tactile exit sign with raised characters and braille at exit doors. Mount the sign between 48" - 60" above the finished floor on the latch side of the door.	2	116	\$232
Additional Access												
20	Near Cafeteria	1		Drinking Fountains	Low

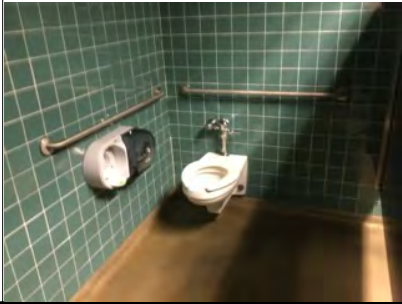
Non-compliant toilet paper dispenser	-	Replace dispenser that does not allow continuous paper flow.	1	353	\$353

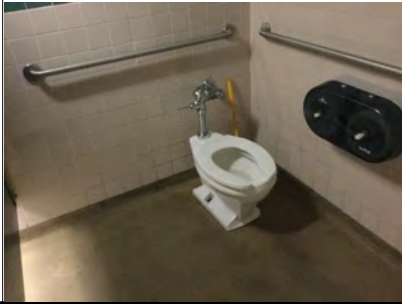
Door has malfunctioning self-closing hinge Non-compliant toilet paper dispenser Centerline < or > 18" (MAAB)	- - 16"	Repair hinge. Replace dispenser that does not allow continuous paper flow. Toilet centerline does not comply with 521 CMR but does comply with the ADA. It is not entirely compliant, but usable.	1	Labor 353	\$353

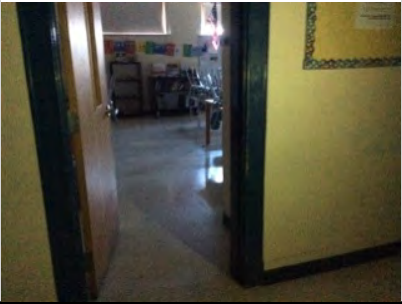
Best Practice: Recommend providing signage at all classrooms to improve access and create consistent wayfinding.	1	-	\$0
Best Practice												
78	Elevator	3

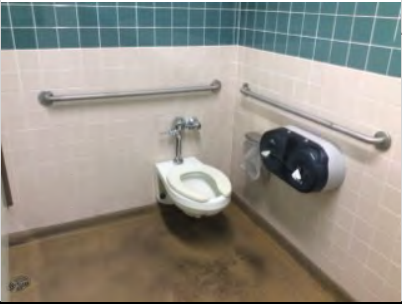
Non-compliant toilet paper dispenser Centerline < or > 18" (MAAB)	- 17"	Replace dispenser that does not allow continuous paper flow. Toilet centerline does not comply with 521 CMR but does comply with the ADA. It is not entirely compliant, but usable.	1	353	\$353
Toilet & Bathing Rooms												
82	Girls' Toilet Room Near 321	3		Toilet Compartment	Accessible Compartment

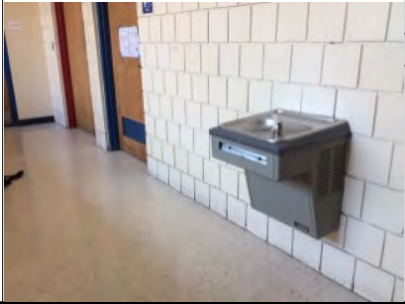
Operable parts malfunctioning No drinking fountain provided for standing users	- -	Install a Hi-Lo drinking fountain.	1	2108	\$2108
Access to Goods and Services												
86	Hallway Near 355	3		Ramps	Interior

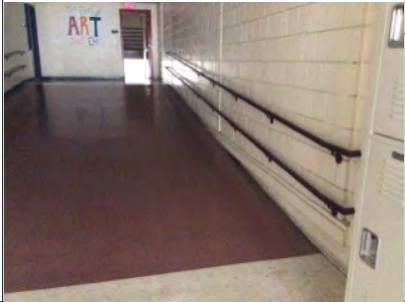
Handrails < 34" or > 38" above ramp surface. Handrails do not extend 12" past top & bottom	31" -	Alter so the handrails are 34"- 38" high above the floor. Alter handrails to extend horizontally above the landing for 12" min. beyond the top and bottom of ramp runs.	1	Labor 400	\$400
Access to Goods and Services												
99	Classroom	3	332	Doors, Doorways, & Gates	Classroom

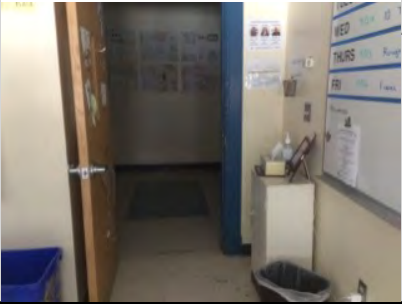
Maneuvering clearance not provided at recess > 8"	-	Relocate the storage out out of the door maneuvering clearance.	1	Labor	\$0
Access to Goods and Services												
103	Special Education Classroom	3	338	Interior Access Route	N/A
